AFRL-VA-WP-TR-2003-3010

CORROSION PIT TO CRACK TRANSITION

Delivery Order 0051: Task 2

Final Report for 15 May 2002 – 20 December 2002

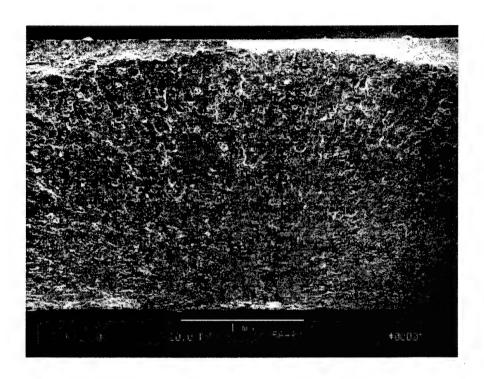
Figure 2. Crack Nucleation Site

An example of a crack nucleation site is illustrated in the higher magnification photo of the fracture surface in Figure 2. Figure 3 illustrates a still higher magnification area of the same site shown in Figure 2. Evidence of corrosion can be observed at the origin of the crack.

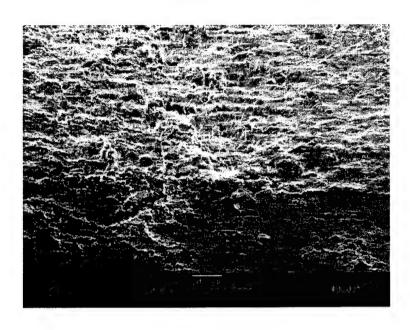
Figure 4. Corrosion at Crack Nucleation Site

Once corrosion is located at the crack nucleation sites, additional photographs were obtained at different angles to document the corrosion on the specimen front face. (The specimens were originally corroded on one side, referred to as the front face.) An example of this type of observation is illustrated in Figure 4 for the same crack origin area illustrated earlier in Figure 3. Figure 5 shows a higher magnification photo of the same region. The lighter gray region in Figures 4 and 5 is the fracture surface. The darker area is the corroded front face of the specimen.

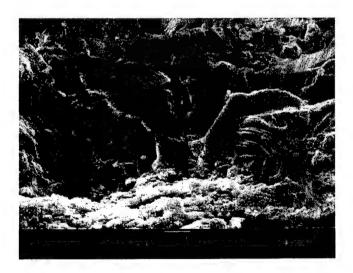
Figure 7. Fracture Surface Features Surrounding the Corrosion at the Nucleation Site

The fracture surface surrounding the corrosion at the crack nucleation sites were photographed. Figure 7 shows an example of this type of observation. The darker area in the upper part of the photograph is the fracture surface. The lighter area near the bottom is the corrosion pit. The area contains striations and microcleavage surrounding the corrosion pit at the crack nucleation site. Other details of how the failure progressed that can be identified, especially when the cracks were small, were also documented.

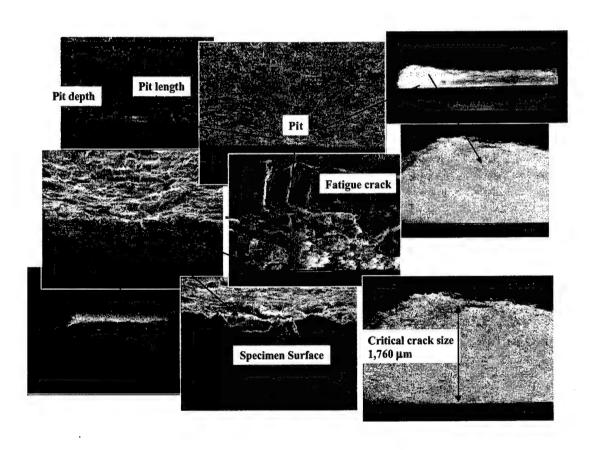
Figure 9. Fracture Surface of Specimen 43-1 Showing Single Crack-Nucleating Pit and the Critical Crack

• In about half of the specimens examined, shown for example in Figure 9 for specimen 43-1, a single pit is identified to nucleate the dominant crack.

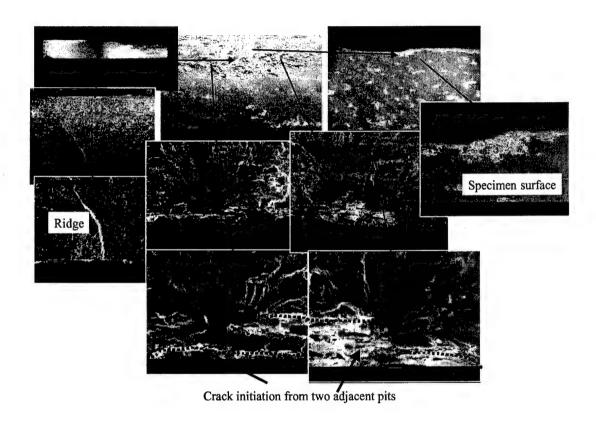
Figure 10. Fracture Surface of Specimen 51-3 Showing Cracks Nucleating From Adjacent Pits and Coalescing Into Single Crack

• In some cases, shown for example in Figure 10 for specimen 51-3, cracks nucleated from two adjacent pits and coalesced, as evidenced by the ridge in the fracture surface. However, it is difficult to distinguish the two pits clearly, as they appear to have joined just as the corrosion exposure ended. While there is only one dominant crack, the length of the crack-nucleating pit is considered the sum of the length of both the pits.

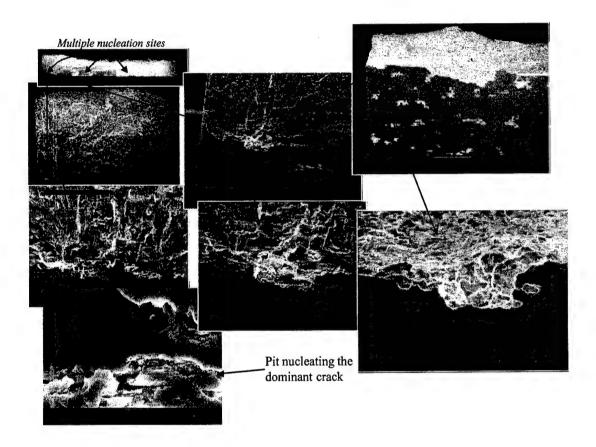
Figure 11. Fracture Surface of Specimen 48-3 Showing Cracks Nucleating From Multiple Pits and Coalescing Into Single Crack

• In a few cases, shown for example in Figure 11 for specimen 48-3, several cracks are observed to nucleate from the fracture surface. These all rapidly coalesced to a single crack for which a nucleating pit can be identified.

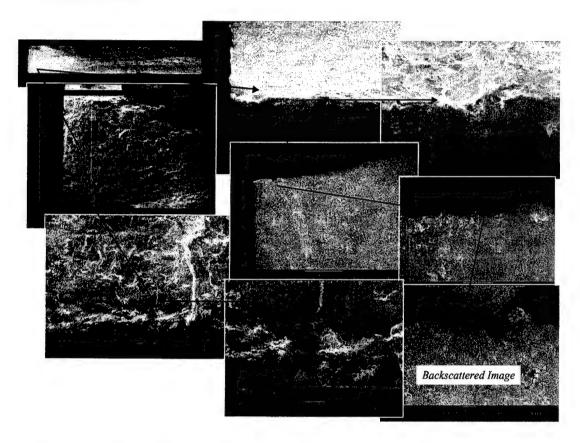
Figure 12. Fracture Surface of Specimen 45-1 Showing a Dominant Crack But No Discernible Pits

In a few cases, shown for example in Figure 12 for specimen 45-1, no pits could be identified because of the nature of surface corrosion, even though one dominant crack still caused the failure.

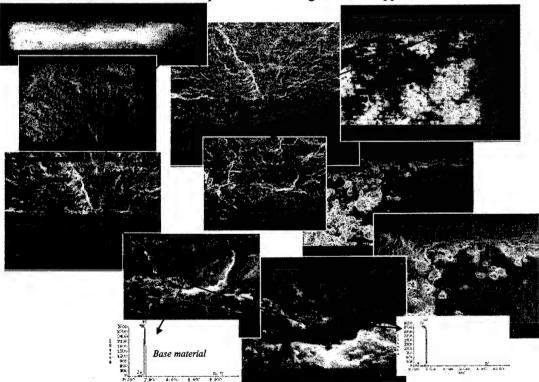
Figure 13. Fracture Surface of Specimen 60-1 Showing EDS Traces

For selected specimens, an energy-dispersive x-ray spectroscopic analysis of the material in the vicinity of the pit and the base material was performed. An example of such observation is shown in Figure 13 for specimen 60-1. While all of the corroded specimens had been cleaned using American Society for Testing and Materials (ASTM) standard procedures to remove the corrosion products, it is impossible to remove them completely. The EDS traces shown in Figure 13 are as expected. The area of the pit shows traces of oxygen consistent with the nature of the corrosion product. The base material adjacent to the pit shows primarily aluminum with signals from the alloying elements, zinc, magnesium and copper. Similar observations are shown for selected specimens in the figures in the appendix.

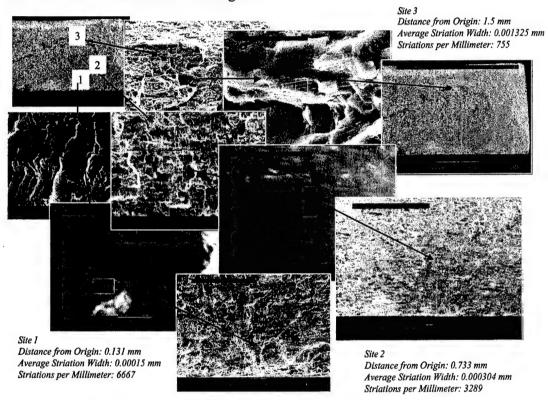
Figure 14. Fracture Surface of Specimen 43-2 Showing Fatigue Striations

the 34 specimens, an examination of striations was made at three locations – close to the origin of the crack in the vicinity of the pit/crack interface (site 1), about midway from the origin (site 2), and close to the critical crack depth (site 3). An example of such observation is shown in Figure 14 for sample 43-2. Similar results for the remaining specimens are included in the appendix. As expected, the number of striations per unit length decreases with increasing distance from the origin due to increasing crack growth rate with increasing crack length and stress intensity. However, for all the specimens, fatigue life estimated from the observed striations was significantly lower than that measured. While there is one dominant crack, local variations in crack growth rates are expected due to multiple crack fronts, which renders estimation of life from striations meaningless.

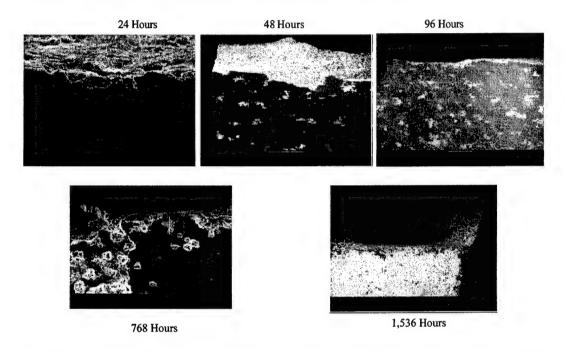
Figure 15. Corroded Surface of Specimen Showing Increasing Surface Density of Pits With Increasing Corrosion Exposure

not account for the surface density of the pits, i.e., the number of pits per unit area. In addition to the length, width, and depth of the pits, the surface density also increases with increasing corrosion exposure. This renders unambiguous distinction of pits very difficult in both the corroded panels and the fracture surfaces. Two or more adjacent pits may then appear to nucleate the same crack, as shown in Figure 10. Due to the interaction of adjacent pits, the dimensions of the crack-nucleating pit measured from the fracture surfaces would then be higher than its intrinsic dimensions. This uncertainty would appear to increase with increasing corrosion exposure and the correspondingly increasing surface density of the pits, as illustrated in Figure 15. It should also be noted that one (specimen 59-2) of the four specimens for which pits could not be clearly measured in the fracture surface was exposed for 768 hours, and two (specimens 61-2 and 63-2) of these four specimens were exposed for 1,536 hours.

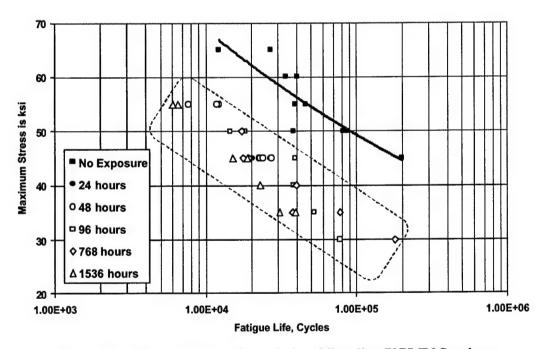
Figure 16. Fatigue Lives of Corroded and Baseline 7075-T6 Specimens

The measured fatigue lives of the 34 corroded specimens examined in this investigation are shown in Figure 16. The measured lives of bare, noncorroded baseline 7075-T6 specimens are also shown. The life of the noncorroded 7075-T6 specimen at a maximum stress level of 45 ksi, shown as 200,000 cycles, was obtained from Mil-HdBk-5. Consistent with the results of all earlier studies, fatigue life of 7075-T6 is reduced drastically once corrosion damage is present in the specimen surface, as evidenced by the large reduction in life following only 24 hours exposure. After this initial reduction, further corrosion exposure appears to reduce life only little.

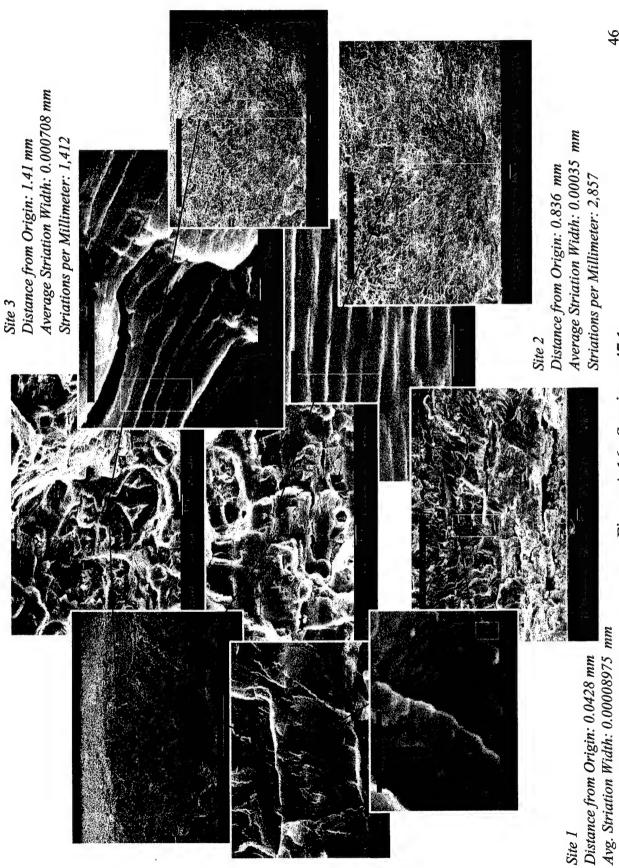
Figure A-16. Specimen 47-1

Striations per Millimeter: 11,142

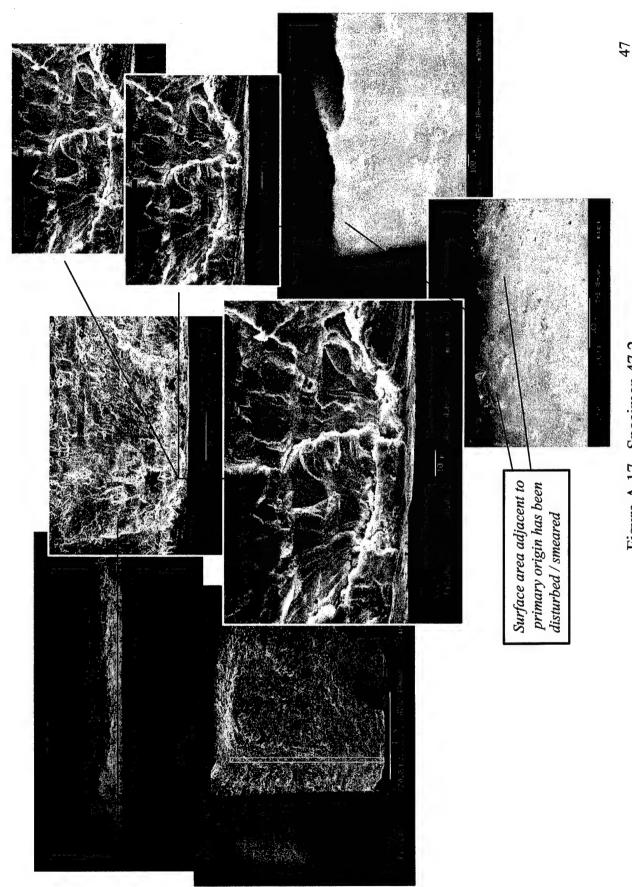
Figure A-17. Specimen 47-2

Average Striation Width: 0.0003 mm

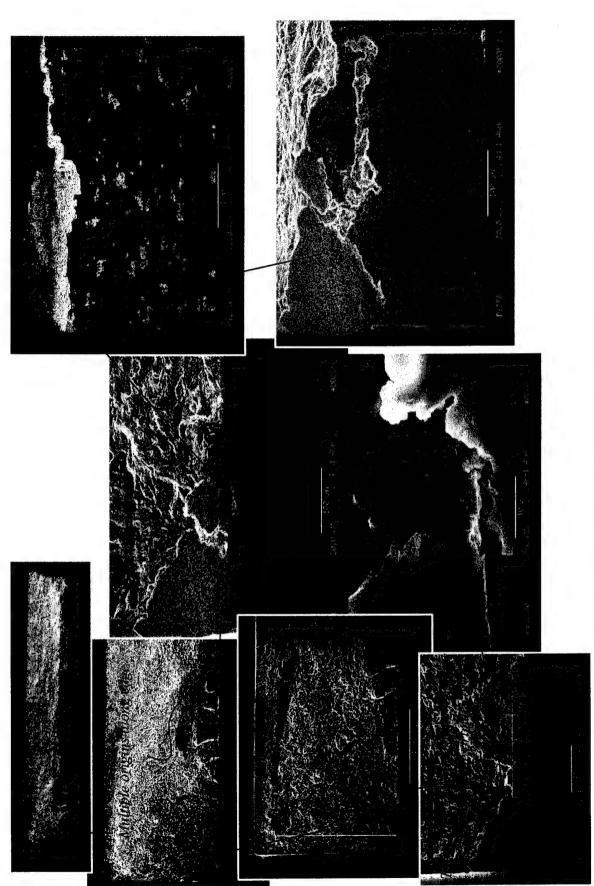
Figure A-21. Specimen 48-1

Note: Due to damage at origin, only visible section of pit was used to determine it 's length.

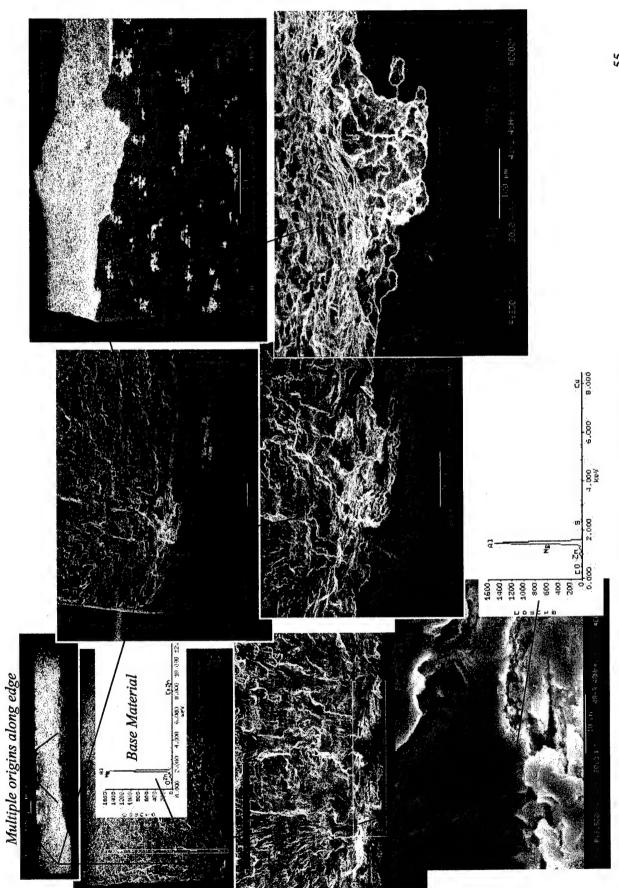
Figure A-25. Specimen 48-3

Section 2, Introduction and Background, reviewed the results of a number of prior investigations, which all showed that in specimens containing localized surface corrosion damage such as pitting, fatigue always initiates at these preexisting damage sites. In addition, individual fatigue cracks would also be expected to nucleate from all the pits present on the corroded surface, because in polycrystalline materials, preexisting surface damage can initiate a crack immediately upon application of a load (15). However, all these cracks would coalesce early into one or few larger cracks, which would eventually lead to a dominant crack, as observed in all of the specimens investigated. Smaller secondary cracks, when observed such as in specimen 48-3 (Figure 11), probably initiated later in the test.
